APPENDIX B - INVESTIGATION PHOTOGRAPHS

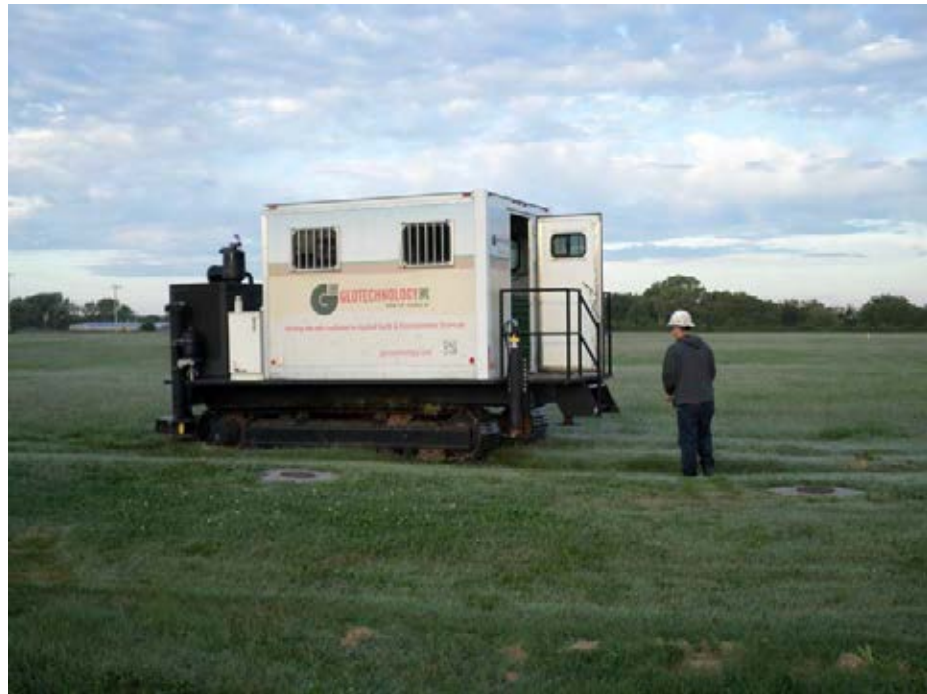
Photo 1 – Specialized track-mounted CPT probe rig (remotely operated). Photo looking west with petroleum recovery trench in foreground (berm with bolted well covers). **Photo 2** – Typical set-up of CPT probe rig and LIF support truck for investigative borings. Photo at LIF-1 looking east.

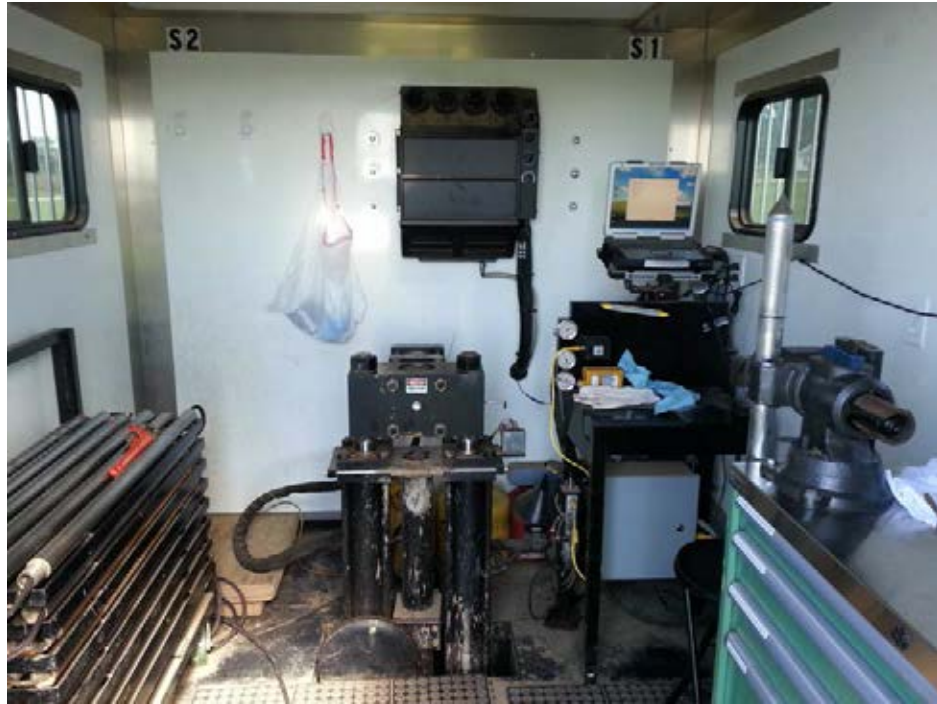
Photo 3 – Inside of CPT probe rig. **Photo 4** – CPT and LIF devices. The CPT tool was equipped with electronic devices that continuously measure cone tip resistance, sleeve/skin (local) friction, and pore water pressure with depth to determine geotechnical properties of soils and provide an interpretation of subsurface stratigraphy. The LIF device (UltraViolet Optical Screening Tool [UVOST®] developed by Dakota Technologies) was equipped in-line with the CPT probe tooling (LIF device is pictured at bottom of CPT tooling) to measure and record wavelengths and relative intensity of the LNAPL fluorescence in soil. Due to the configuration of the tooling, there is an offset from CPT data to UVOST LIF data of 2.7 feet, measured from the tip of the cone to the center of the sapphire window.

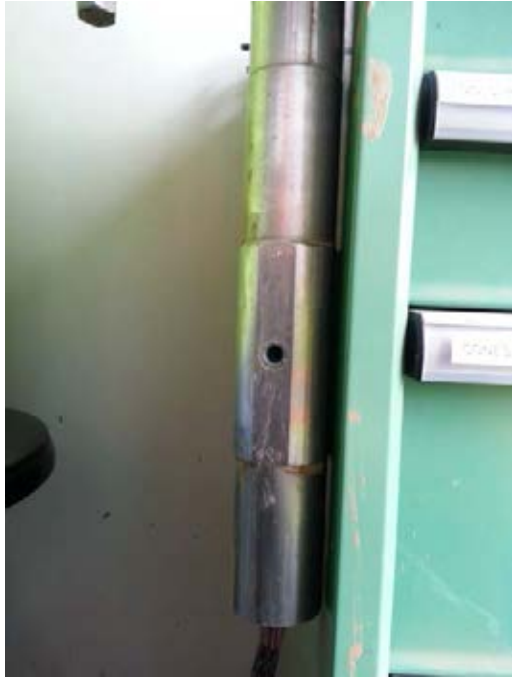
Photo 5 – Close-up photo of LIF device (in-line with CPT tool) where pulsed UV light produced from a laser is sent through the sapphire window (hole in tooling) to stimulate the fluorescence of aromatic hydrocarbons found in LNAPLs in soil. **Photo 6** – Typical CPT operations showing CPT threaded piping (with CPT/LIF data cables strung inside) loaded into hydraulic press to advance CPT/LIF devices into the subsurface. **Photo 7** – Typical LIF UVOST® system that sends UV light through a fiber optic cable strung through CPT probe rods that exit through the sapphire window in the side of the probe (see Photo 5). The fluorescence emitted from soils (the “signal” light) is transmitted through a second fiber optic cable, back up hole to be analyzed. Responses are graphed in real-time log (signal vs. depth) that can be viewed on a field laptop and printed.

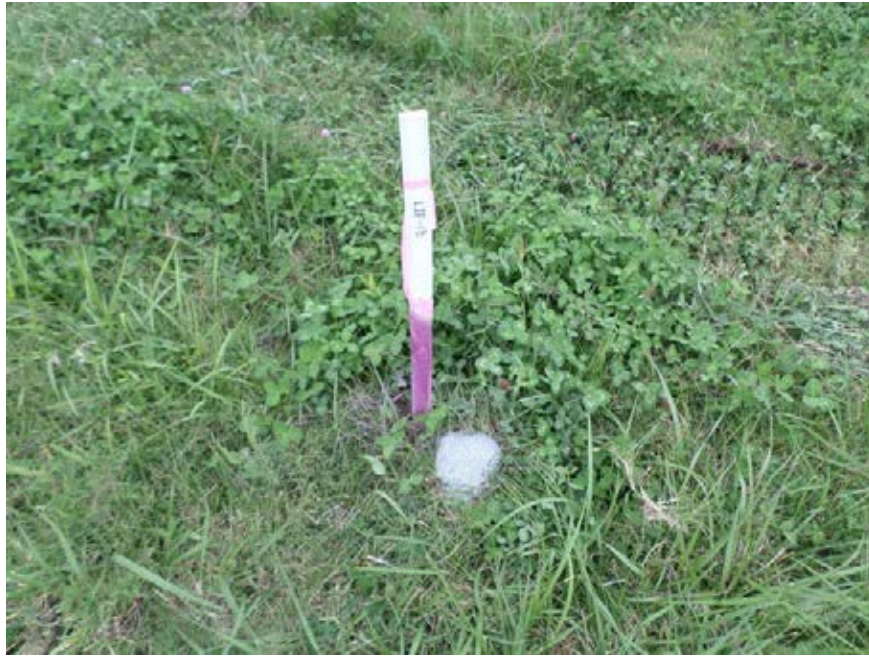
Photo 8 – Typical CPT/LIF borehole abandonment in grass performed by backfilling with granular bentonite to ground surface. Photo taken at LIF-18. **Photo 9** – Typical CPT/LIF borehole abandonment in asphalt road performed by backfilling with granular bentonite to near ground surface (within approximately 6-inches bgs) and placing asphalt patch as surface cap/seal. Photo taken at LIF-44. Yellow and Blue “OK” in foreground of photo represents marked utility clearance by City of Neodesha for gas and water, respectively.

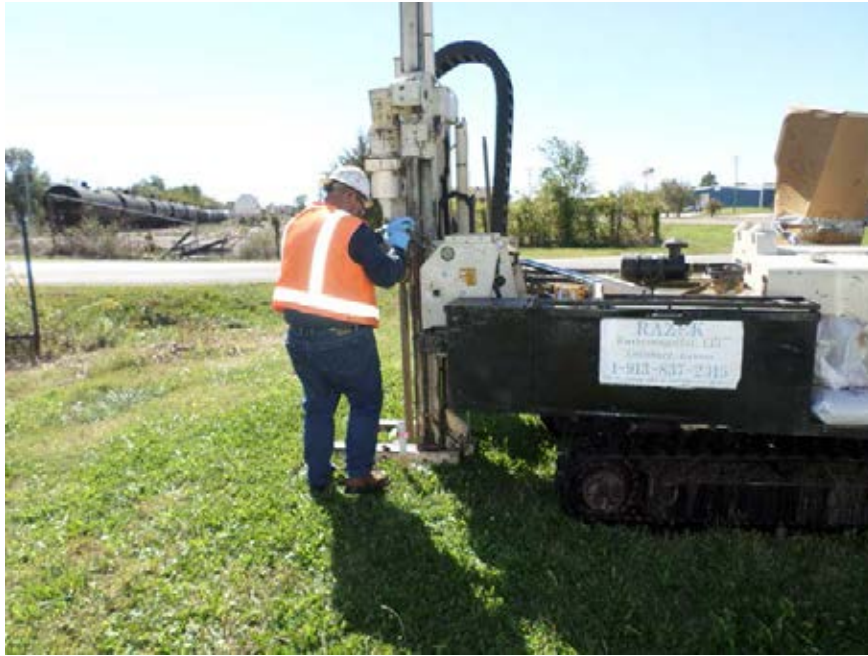
Photo 10 – Typical continuous soil sampling using direct-push probing, adjacent to LIF-3 (photo looking south), for subsurface logging purposes to compare select CPT lithologic interpretations.
Photo 11 – Typical continuous soil sampling using direct-push probing, at Monitoring Well MW-169 (photo looking north-northeast), for lithologic logging purposes prior to well installation activities.

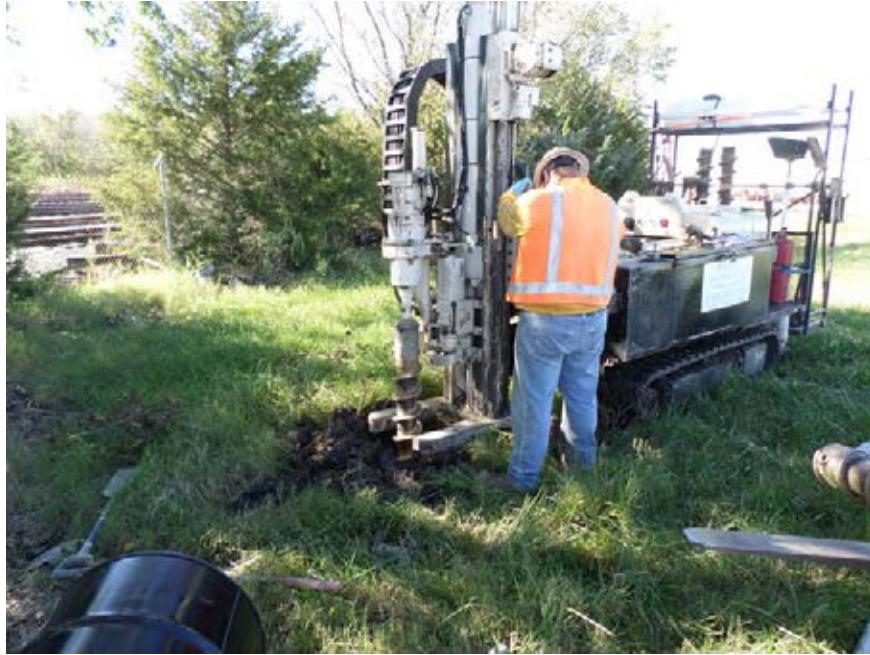
Photo 12 – Typical hollow-stem auger (HSA) drilling for well installation activities (following continuous soil sampling for logging purposes). Photo taken at Monitoring Well MW-164 looking west-northwest. **Photo 13** – Typical well installation/construction through HSAs; pouring filter pack sand through HSAs. Photo taken at Monitoring Well MW-152 looking south. Soil cutting generated during continuous sampling and HSA drilling were containerized in 55-gallon drums and staged in a gravel lot behind the remediation building.

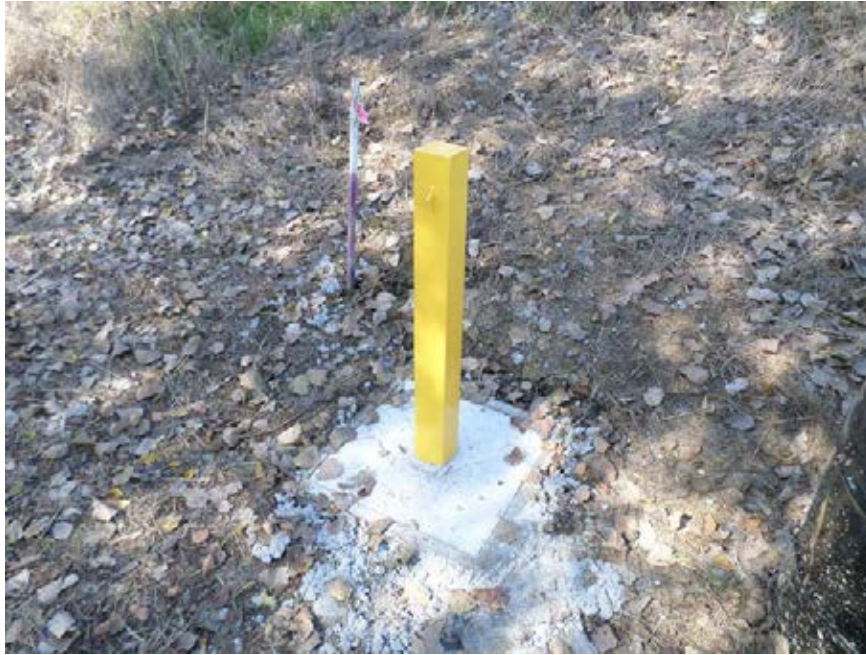
Photo 14 – Typical surface completion for above ground monitoring wells. Photo taken at Monitoring Well MW-146 looking north-northwest. **Photo 15** – Typical surface completion for flush-mounted ground monitoring wells. Photo taken at Monitoring Well MW-168 looking west. Investigative-derived waste (IDW) drum with soil cuttings shown in left of photo with “Non-Classified Waste Material – Laboratory Analysis in Progress” label (all IDW drums relocated to gravel lot behind remediation building).

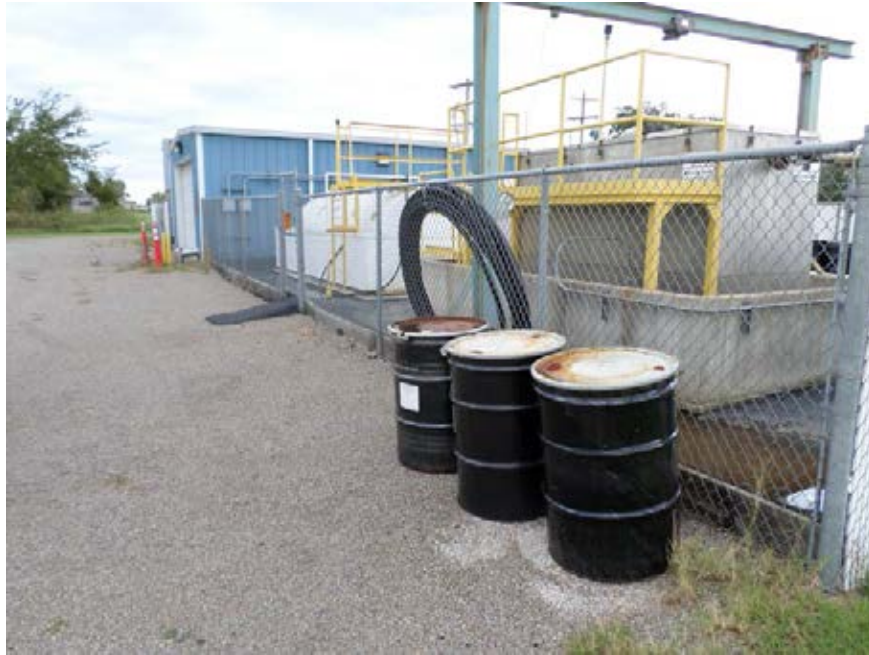
Photo 16 – Staging area for IDW drums during investigation behind remediation building on gravel lot. Photo looking north-northeast; not all IDW drums pictured (photo taken at start of investigation). **Photo 15** – Typical IDW drum label.

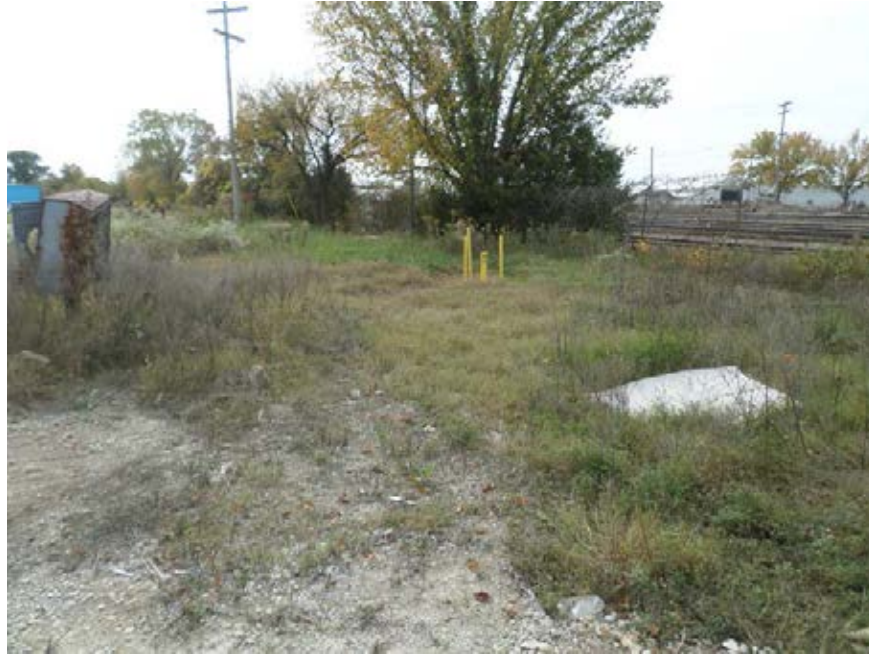
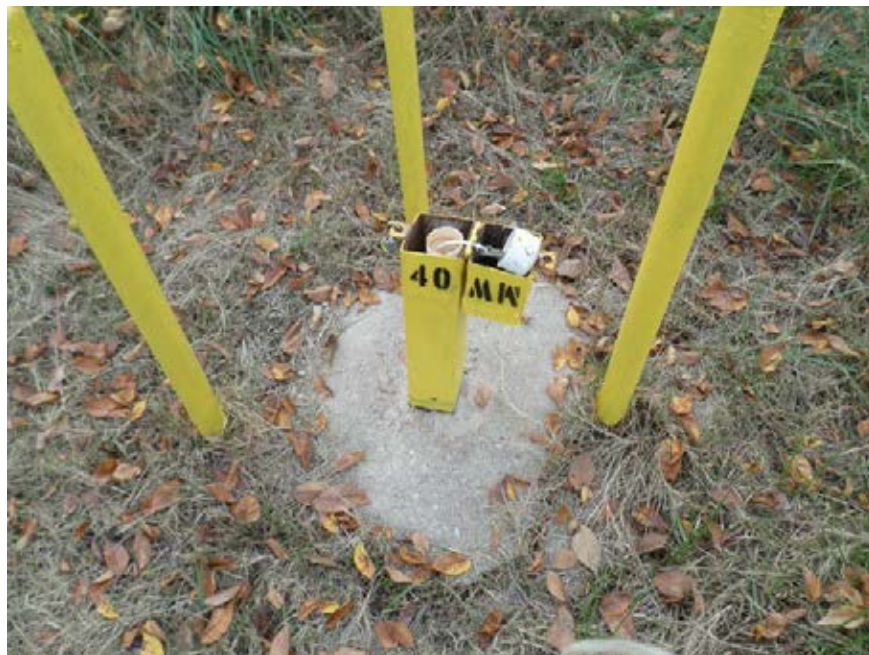
Photos 18 and 19 – Monitoring Well MW-40 prior to abandonment. Well consisted of 2-inch diameter PVC well casing. Photo looking south-southwest.

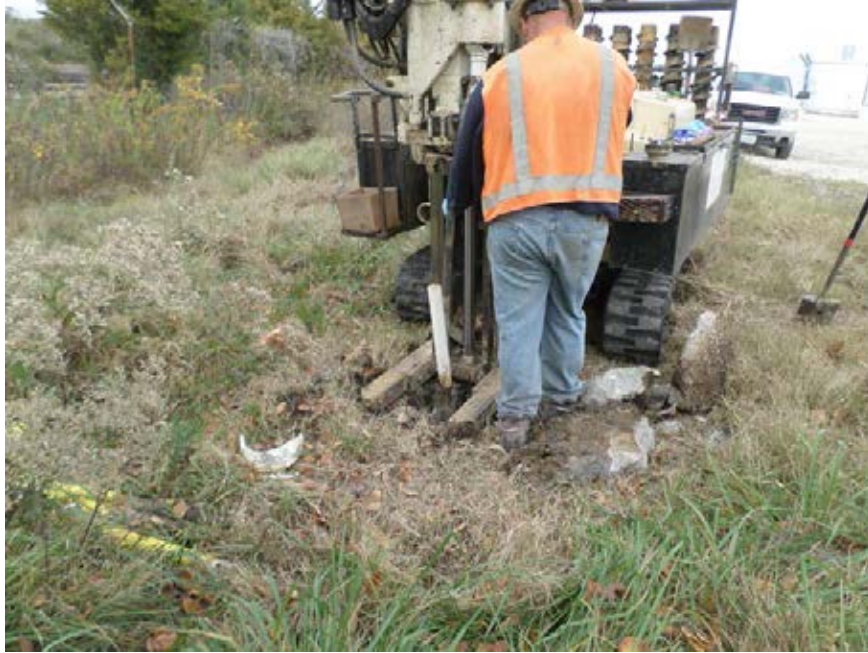
Photo 20

Photos 20 – Abandonment activities at Monitoring Well MW-40. Protective well casing, bollards (3), and concrete pad removed. Attempts of pulling well casing out of ground were unsuccessful. The top five (5) feet of the well casing was removed and bentonite chips were poured into well to approximately three (3) feet bgs. Photo looking north. **Photos 21** – Completion of abandonment activities.
