APPENDIX B - INVESTIGATION PHOTOGRAPHS

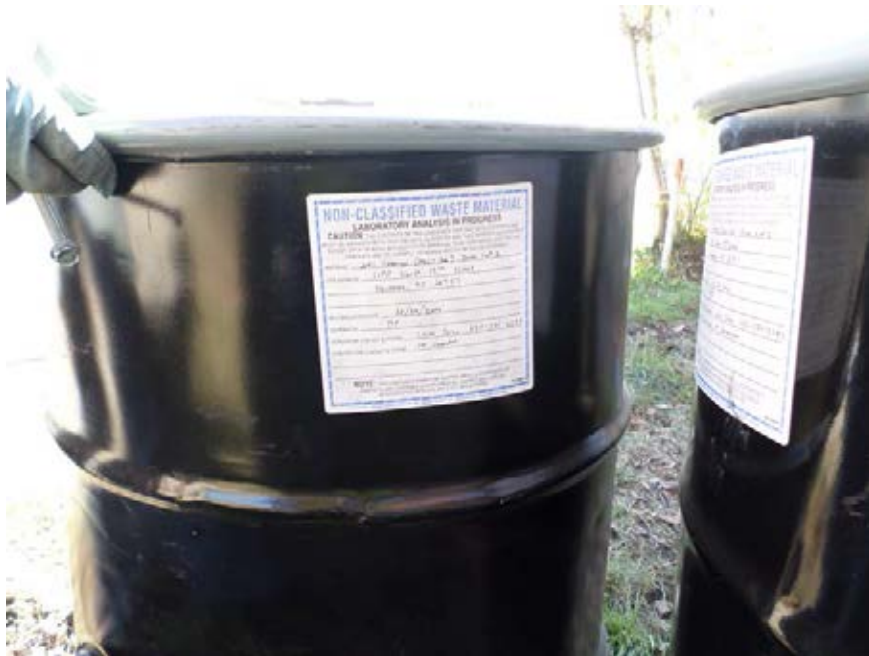
Photo 17

Photo 16 – Staging area for IDW drums during investigation behind remediation building on gravel lot. Photo looking north-northeast; not all IDW drums pictured (photo taken at start of investigation). **Photo 15** – Typical IDW drum label.
